Manhole Inspection Summary

Manhole # S29K__072MH

Insp Date: **10/27/08 9:23 AM**

Location Address: **830 Clifford St**

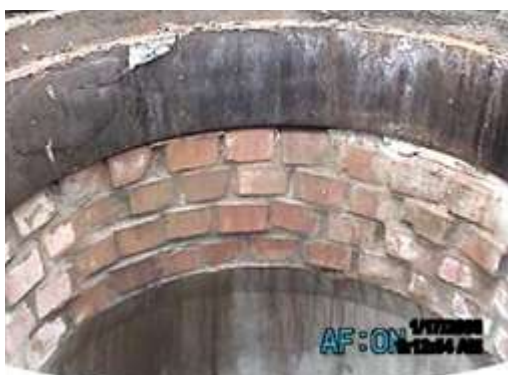
Defect 3

Frame Offset: **0** (in.) Condition: ☐ Sound ☐ Cracked ☒ **Leaks**

lid/frame infiltration

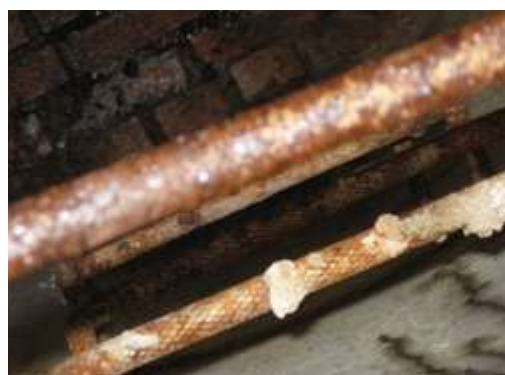
Defect 2

Steps Count: **7** Missing: **0** ☒ **Corroded**

oxidized rungs

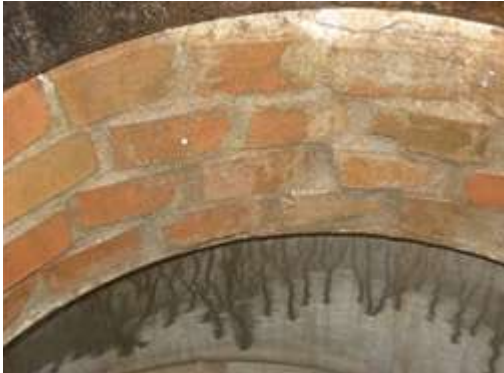
Defect 1

Infiltration: ☐ None ☒ **Joint** ☐ Cracks ☐ Mortar ☐ Roots ☐ Wall

infiltration chimney/corbel joint

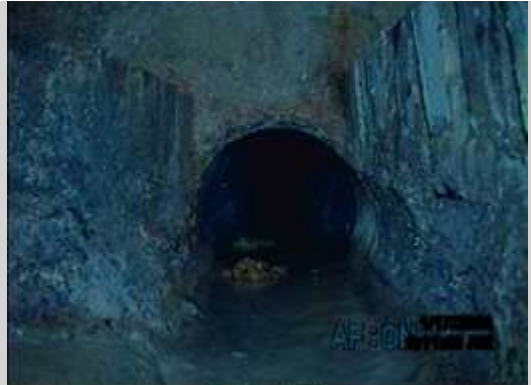
12 O'Clock Outflow

8 in. Circular Gravity Sewer
Pipe Out @ 12 O'Clock

Pipe Height: **8.4** (in.) Rod and Bar (Angled)
Pipe Material: **Clay** ☐ Pipe Lined
Invert Depth: **9.50** (ft.) Flow Characteristics: **Fast**
Deposits: ☒ None ☐ Mud ☐ Sludge ☐ Debris ☐ Grease
Silt Depth: **0** (in.) Deposits Extent:
Infiltration: **None** Pipe Seal Cond: **Sound**

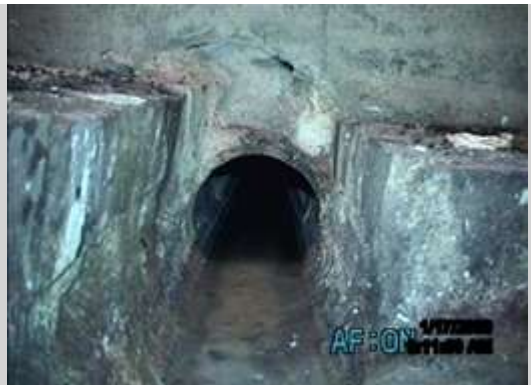
6 O'Clock Inflow

8 in. Circular Gravity Sewer
Pipe In @ 6 O'Clock

Pipe Height: **8.4** (in.) Rod and Bar (Angled)
Pipe Material: **Clay** ☐ Pipe Lined
Invert Depth: **9.50** (ft.) Flow Characteristics: **Fast**
Deposits: ☒ None ☐ Mud ☐ Sludge ☐ Debris ☐ Grease
Silt Depth: **0** (in.) Deposits Extent:
Infiltration: **None** Pipe Seal Cond: **Sound**

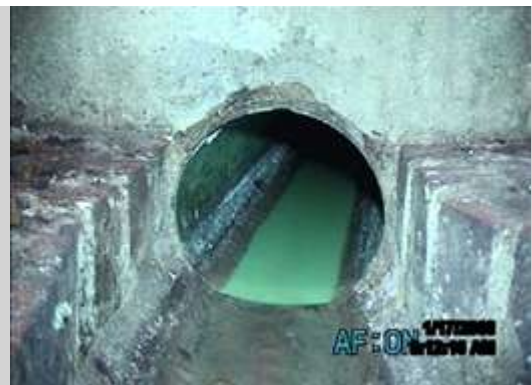
9 O'Clock Inflow

8 in. Circular Gravity Sewer
Pipe In @ 9 O'Clock

Pipe Height: **8.4** (in.) Rod and Bar (Angled)

Pipe Material: **Clay** ☐ Pipe Lined

Invert Depth: **9.24** (ft.) Flow Characteristics: **Fast**

Infiltration: **None**

Pipe Seal Cond: **Sound**
